Property Inspection Report

Inspection Date:
01/30/2016

Prepared By:
Merit Home Inspectors
949-552-1930 office
714-720-3121 mobile

- **Estimated Year Built :** 2001
- **Unofficial Sq Ft :** 1900
- **Structure Type :** two story detached home, vacant
- **Inspection Attendees :** clients and brother, clients agents

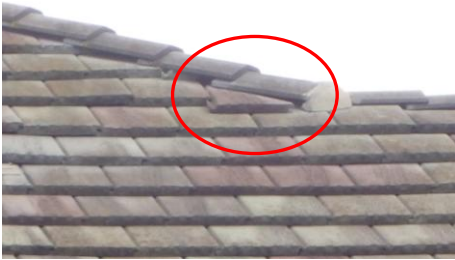
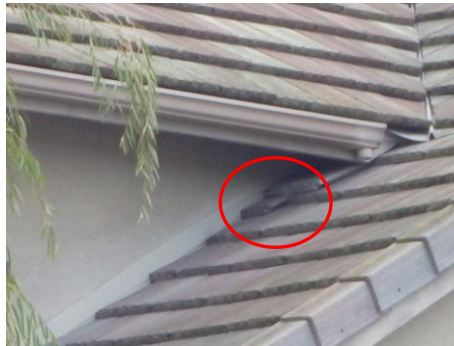
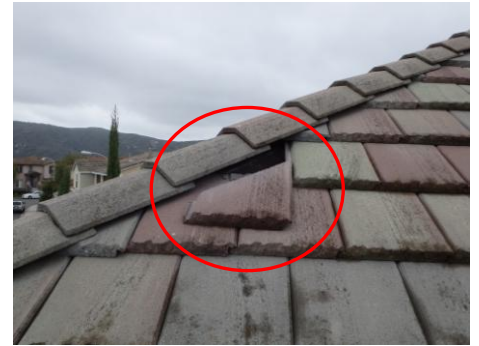
Item 2 •Repair: There are several loose or sliding roof tiles that need repair. As we do not walk this type of roof, there may be additional sliding or damaged roofing that was not in view at the time of the inspection. Recommend consulting a licensed roofing contractor to further evaluate the complete roof. These are just a few sample photos.

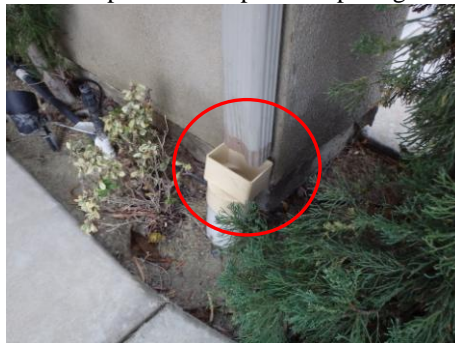
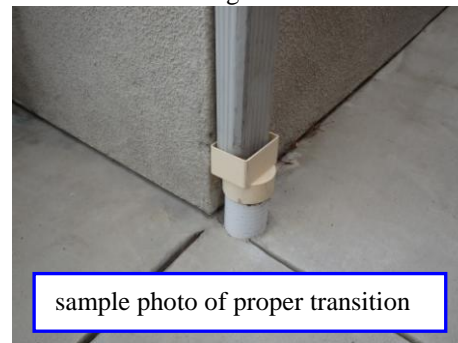
Item 3 •Repair: A misaligned rain gutter downspout transition to the underground drain was noted at the front left corner of the house. This should be repaired to help avoid spilling roof runoff around the building.

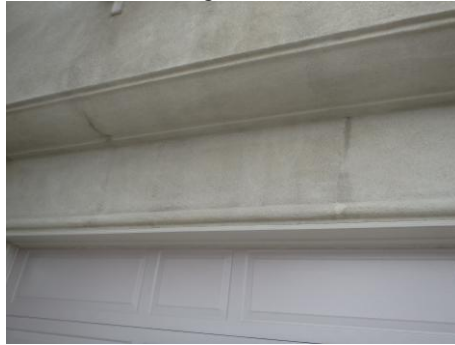
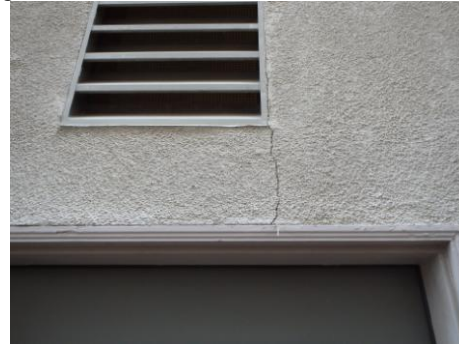
Item 4 •Monitor: Cracks and localized damage of the exterior stucco was observed in some areas around the house. The size, shape and location of these areas are commonly caused by settlement and normal wear and tear of the home. The inspection did not find evidence of significant movement or damaged.

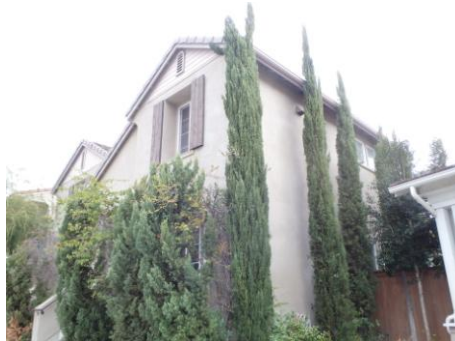
Item 5 •Repair: The vegetation should be trimmed away from the house to help reduce the risk of insect and moisture damage.

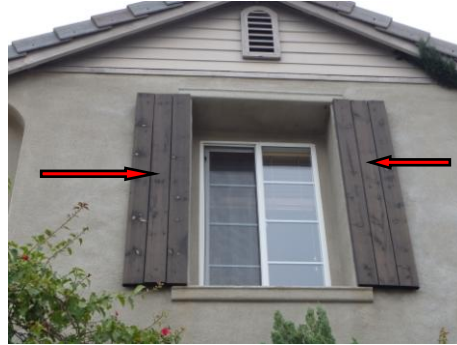
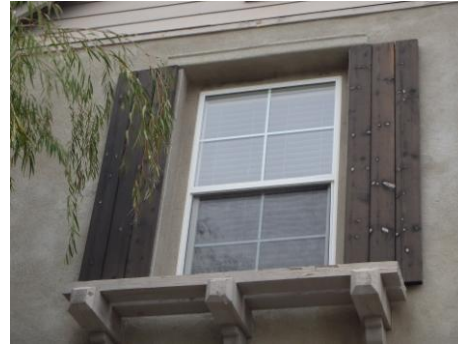
Item 6 •Repair: The exterior trim is faded in some areas and should be painted to help protect it from the elements of the weather.

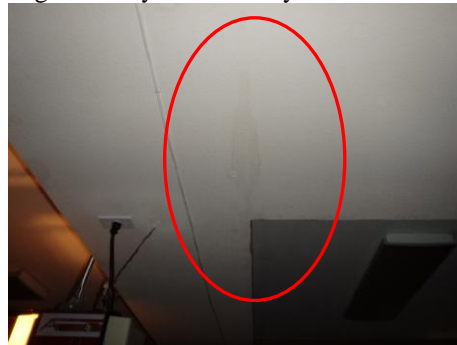
Item 7 •Monitor: An apparent staining was noted at the garage ceiling. The area was dry at the time of the inspection. The extent of the damage behind this area is unknown. The stains may have been caused by an old leak that has been repaired but additional investigation may be necessary. This area should be closely monitored.

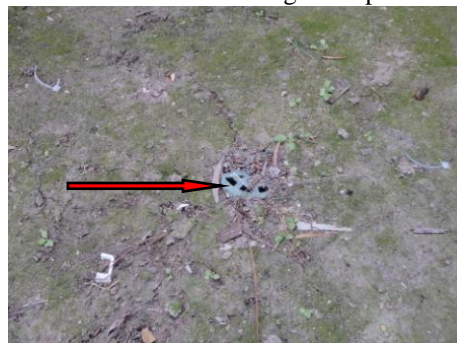
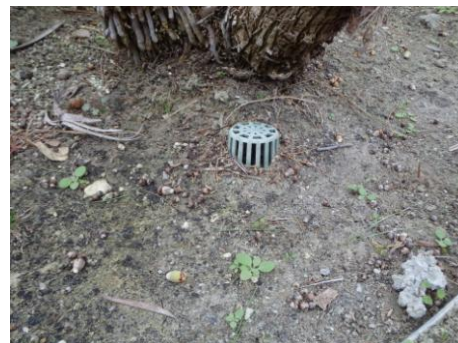
Item 9 •Repair: Some backyard exterior floor drain covers appear to be obstructed and will likely need to be cleared to allow proper drainage. There is a chance the underground portion of the drain could also be obstructed.

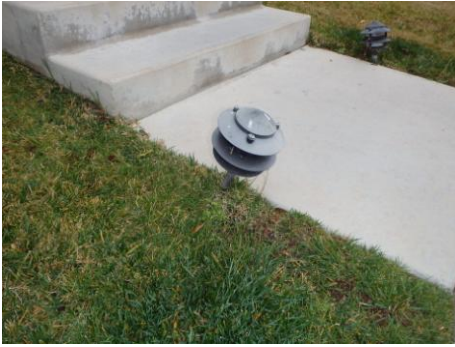
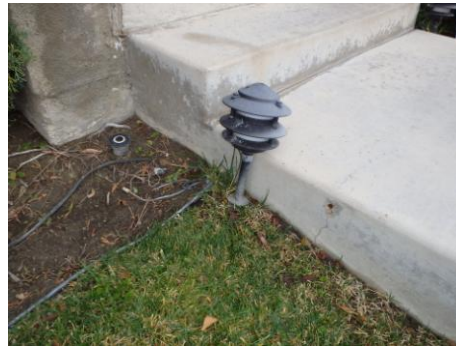
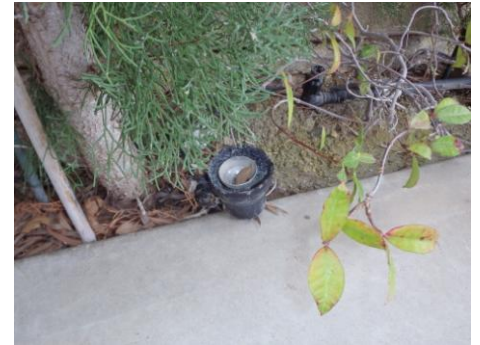
Item 10 •Repair: Inoperative yard lights around the property at the time of this inspection. If replacement bulbs don't work, the circuit may need repair.

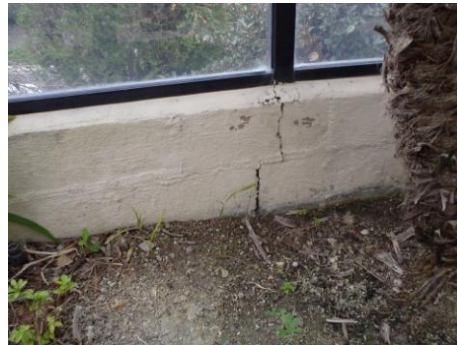
Item 11 •Monitor: The surface of the backyard fencing is cracked in some areas, commonly cause by settlement. This should be closely monitored for additional movement.

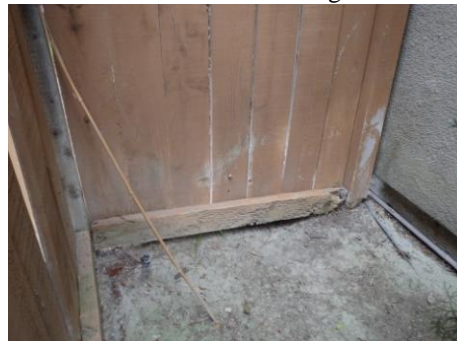
Item 12 •Repair: Deteriorated sections of the fencing were noted.

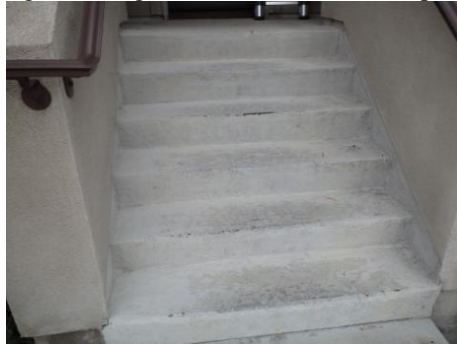
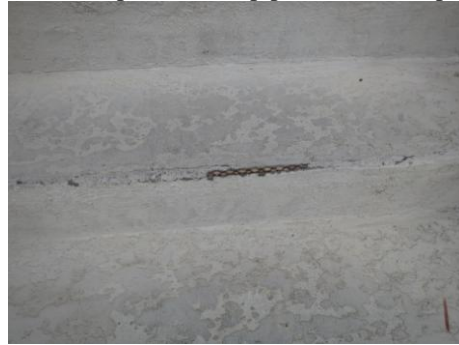
Item 13 •Repair: Damaged coating was noted at the front steps and should be repaired to help preserve the steps.

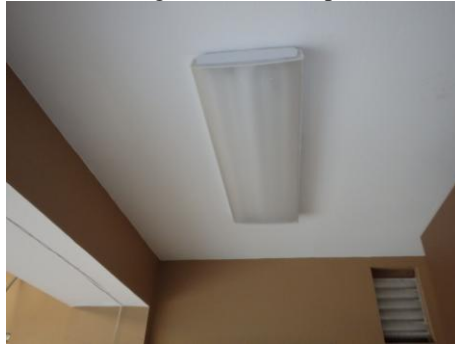
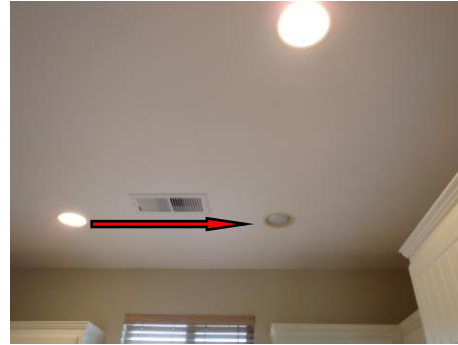
Item 14 •Repair: There are a few lights that are inoperative around the house.

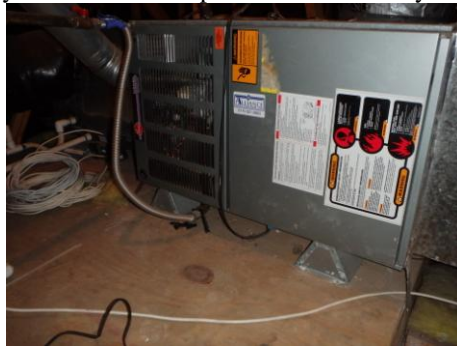
Item 15 The heating unit responded properly to operation controls but is an aging system (manufactured in 2001). As such, it will become slightly more prone to breakdowns. The typical life expectancy for this type of heating system is approximately 25 years. One cannot predict with certainty when repairs or replacement will become necessary.

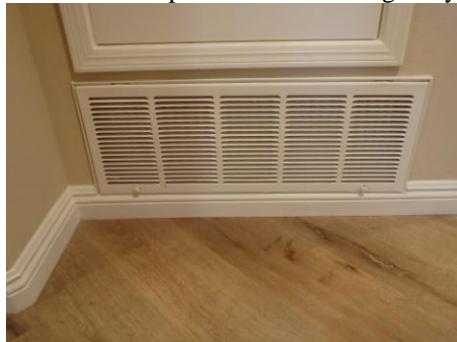
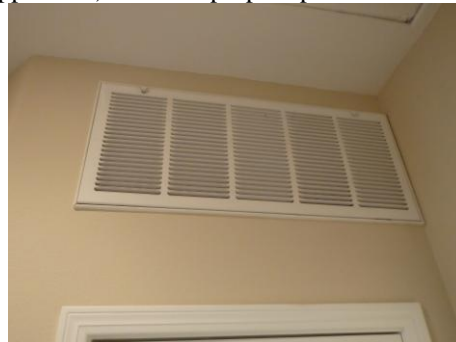
Item 16 •Monitor: The air filters were clean at the time of the inspection but in regards to normal maintenance of the HVAC system, the air filters should be replaced or cleaned regularly (if applicable) to insure proper operation of the system.

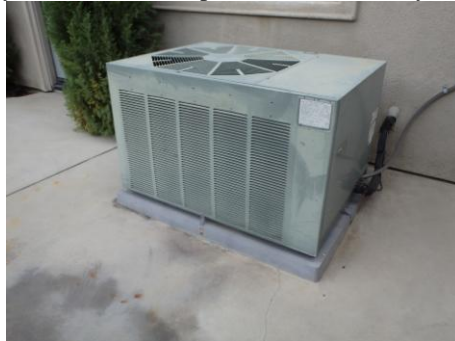
Item 17 The cooling unit responded properly to operation controls but is an aging system (manufactured in 2001). As such, it will become slightly more prone to breakdowns. The typical life expectancy for this type of cooling system is approximately 25 years. One cannot predict with certainty when repairs or replacement will become necessary.

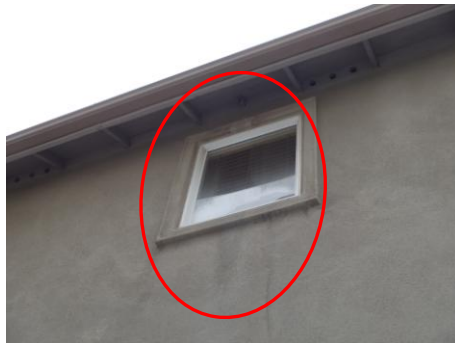
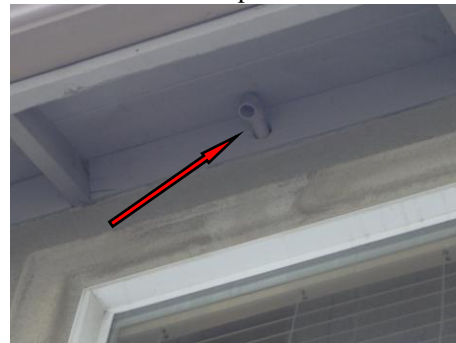
Item 18 •Repair: Water staining was noted at the exterior of the home. It is suspected this staining is from leakage at the air conditioning systems backup overflow line. This leakage is typical for when a problem has occurred at the AC systems primary drain line and the positioning of this exterior pipe is to help alert occupants that the AC system needs repair. A qualified HVAC technician should be consulted to further evaluate this condition and repair as needed.

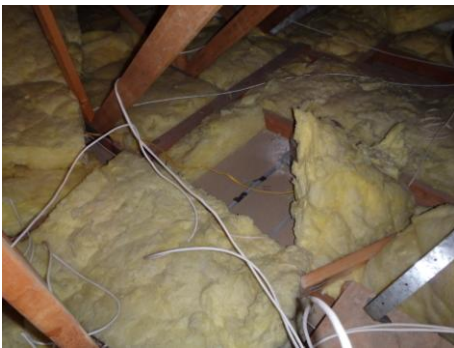
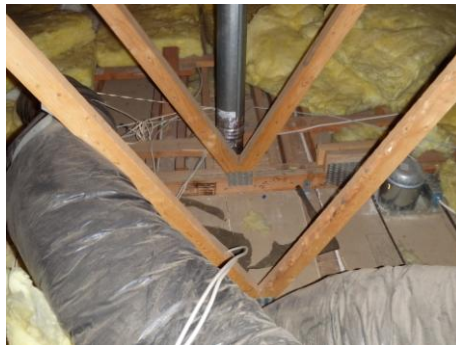
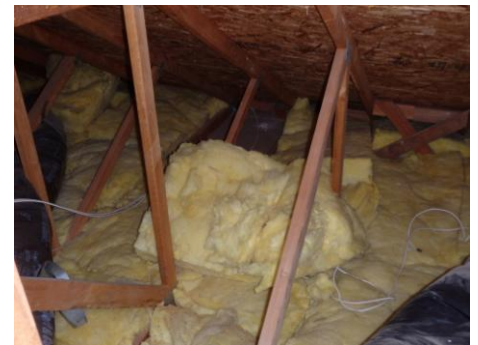
Item 19 •Improve: General speaking the attic is in good condition but some areas have disturbed and missing insulation. Insulation improvements may be cost effective, depending on the anticipated term of ownership.

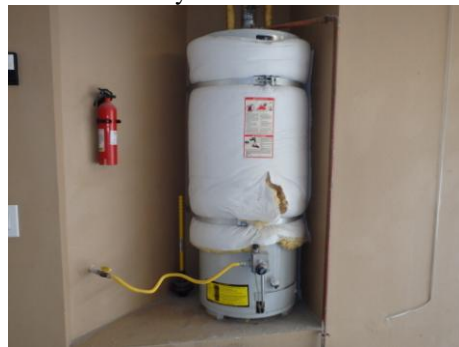
Item 21 •Deferred Cost Item: The water heater was functional at the time of the inspection and has a typical life expectancy of about 10-15 years. This water heater is within this age (manufactured in 2001). One cannot predict with certainty when replacement will become necessary. It is recommended that water heaters sit within a leak pan.

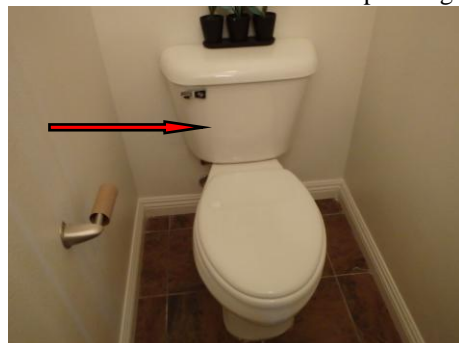
Item 22 •Repair: A loose toilet tank was noted at the upstairs guest bathroom and should be repaired before it starts leaking.

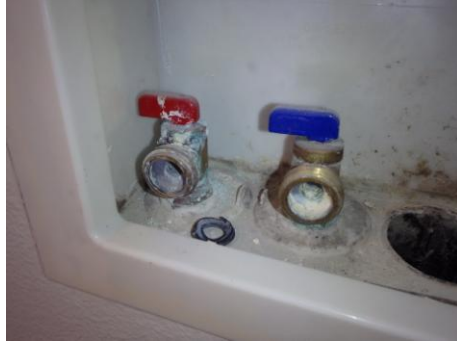
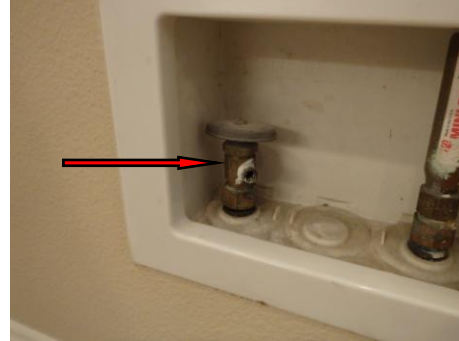
Item 23 •Repair: The shut off valves under sink locations, behind toilet locations, the refrigerator water line and the washing machine hose connections are aging and show signs of corrosion but these valves were not leaking at the time of the inspection. These would be considered a preventative maintenance item and it is recommended these areas be repaired before they start leaking. These are just a few sample photos.

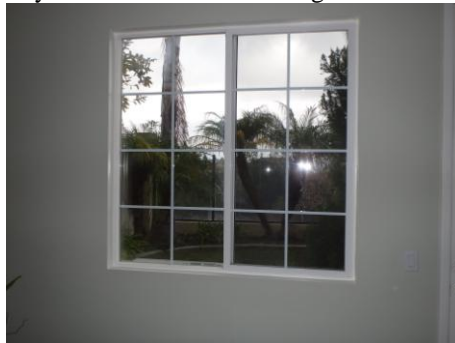
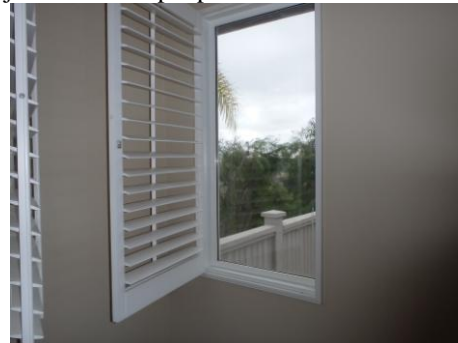
Item 25 •Monitor, Repair: Some windows have lost their seal. This has resulted in discoloration or condensation developing between the panes of glass. This “fogging” of the glass is primarily a cosmetic concern, but you may wish to repair the windows because they have lost some insulating value. These are just a few sample photos.

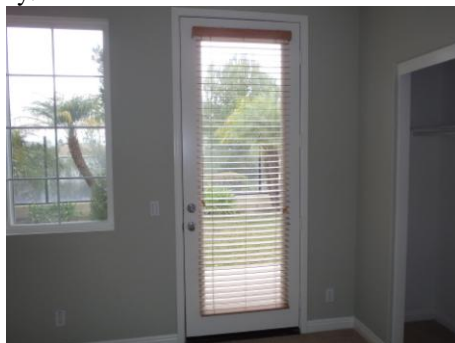
Item 26 •Repair: The backyard door at the downstairs left bedroom is rubbing and may need to be trimmed or adjusted to work more smoothly.

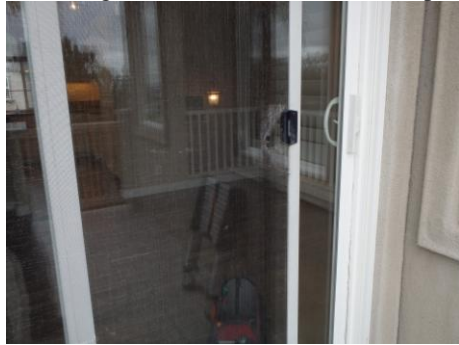
Item 27 •Repair: A torn/damaged screen was noted for the upstairs sliding glass door.

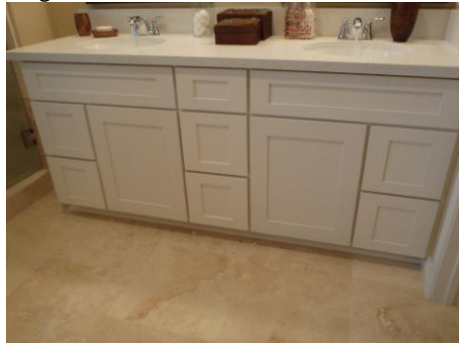
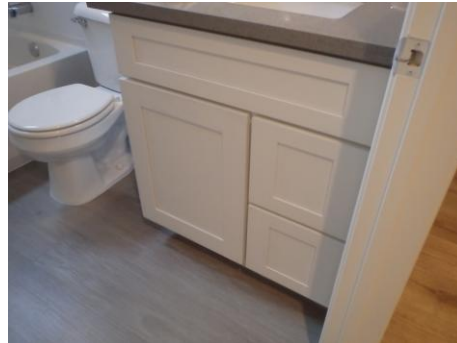
Item 28 •Repair: Missing knobs were noted at the cabinets.

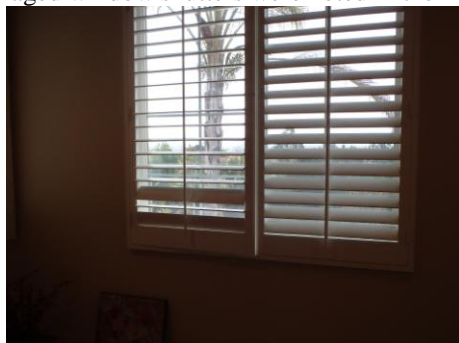
Item 30 •Repair: Damaged window shutters were noted in the master bedroom.

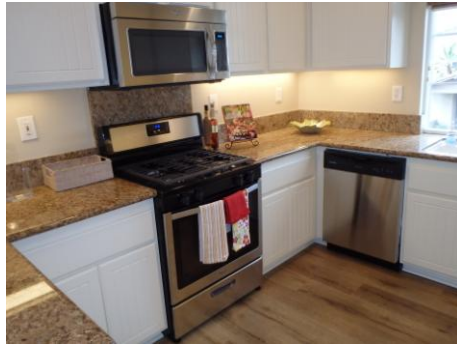
Item 31 The major appliances that were tested responded satisfactory at the time of the inspection.

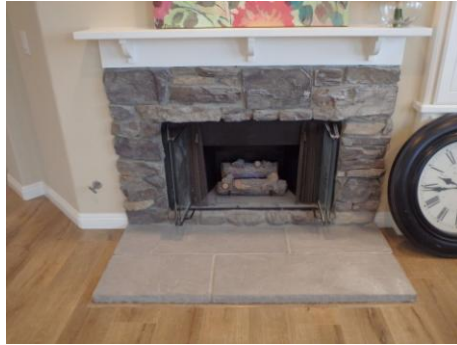
Item 32 On the whole, the fireplace and its components are in good condition.
